Federal Creosote Superfund Site
OU1 Phase 2
Final Remedial Action Report

June 2008

REMEDIAL ACTION REPORT

**LAGOON A REMEDIAL ACTION
FEDERAL CREOSOTE SUPERFUND SITE
MANVILLE, NEW JERSEY**

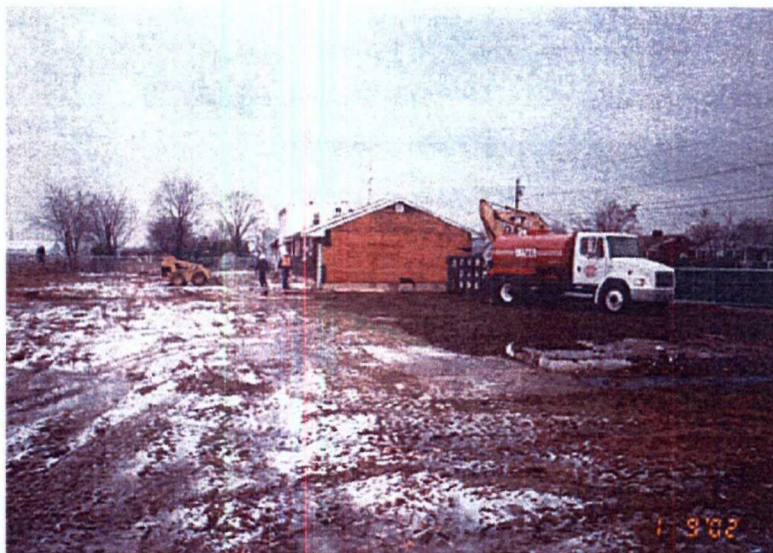
Photo 3-3 – Basement Backfilled – 98 Valerie Drive

Because of the gap in time between the demolition and the remedial action, the basements of the demolished houses were backfilled with 1-½ inch (maximum size) quarry processed material (QP) and secured with a geomembrane cover after the demolition to prevent an open-hole safety hazard. The QP stone was reused during remediation for the construction of access roads.

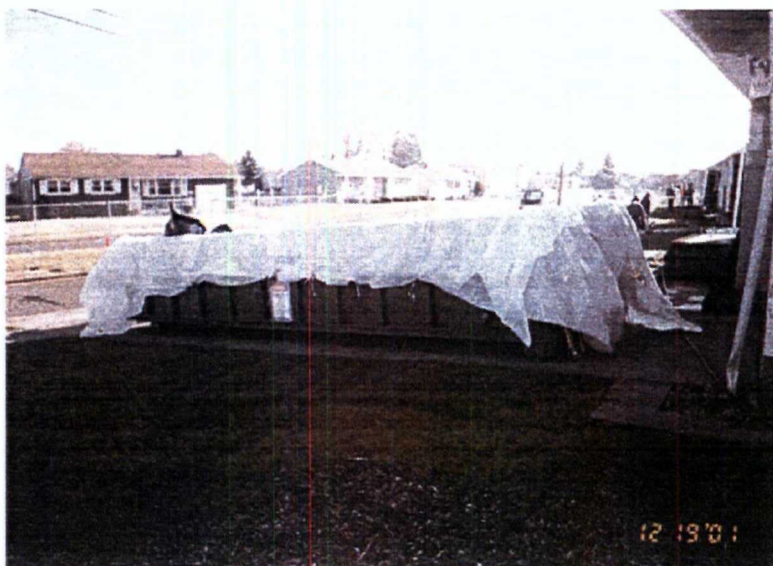
Photo 3-4 – Asbestos Abatement – ACM Waste Container

Subsequent to the confirmatory sampling and prior to the demolition of the houses, CAPE removed and disposed of all ACM. Removal activities were performed in accordance with all applicable Federal, State, and local regulations and the project specifications. A total of 60 CY of ACM including floor tiles, sheet vinyl, siding, etc. was removed from the site and disposed of at Waste Management Tullytown Resource Recovery Facility (TRRF), located at 200 Bordentown Road, Tullytown, Pennsylvania. Copies of the waste manifests are included in Appendix C.

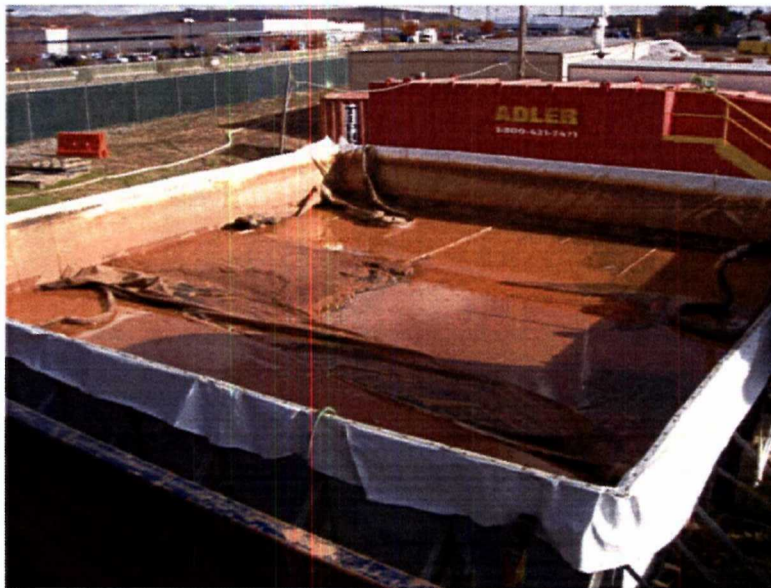
Photo 3-6 – Site Dewatering – Dewatering Treatment System showing sediment basin and equalization tank

The dewatering system was a combination deep well and sumping system. The deep well system controlled the water table to an elevation reasonably close to the interface to permit controlled sumping, and the sump pumping allowed for handling of runoff from other sources, including perched and trapped water above the less permeable and impermeable soil/bedrock. SES's subcontractor, Griffin Dewatering, designed the system, which consisted of 22 perimeter wells, 2 interior common perimeter wells, and 6 sump wells. The common wells were added interior to the perimeter wells, between the two deep excavation areas. Three sump wells were located across each deep excavation area. Well pumps for the perimeter wells were designed at 20 gallons per minute (gpm), and pumps for sump wells were designed at 100 gpm. All water generated from construction dewatering operations was treated at the on-site wastewater treatment plant and discharged to the storm sewer system. The dewatering system design was submitted to NJDEP for permitting. A copy of the permit is included in Appendix E. The pumping system and components were removed and decontaminated at the completion of work by SES.

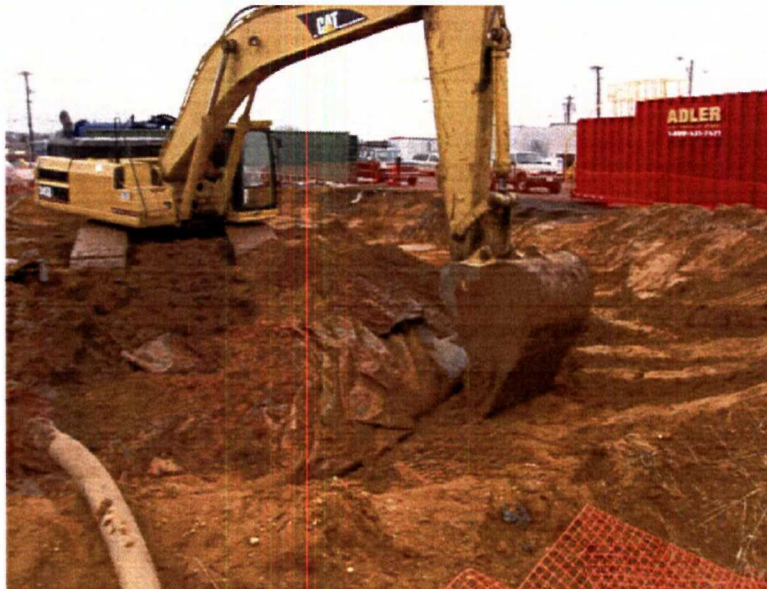
Photo 3-5 – Excavation Operations

Excavated contaminated material was segregated into three distinct stockpiles corresponding to the waste types as summarized in Table 3-2. To avoid cross contamination from one stockpile to another, SES designated an excavator for each stockpile. Stockpiled materials were loaded into lined trucks for transportation to treatment/disposal facilities.

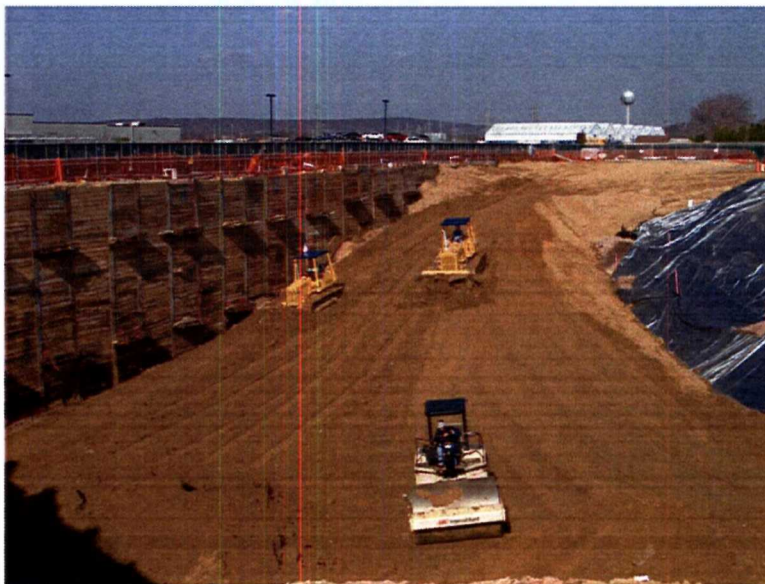
Photo 3-5 - Backfilling Operations

Backfill material was placed directly in the excavation and spread in horizontal layers up to 8 inches thick utilizing bulldozers. Placed material was compacted by utilizing an SD-40D roller to a minimum of 95% of its maximum dry density by Standard Proctor (ASTM D-698). Hand compactors and/or vibratory plates were utilized to compact areas immediately adjacent to houses or other structures. Compaction and moisture content testing of the backfill material was performed by Craig Testing Laboratories, Inc located in Mays Landing, New Jersey.

The upper layer of backfill material consisted of 6 inches of topsoil except in areas below roadways, sidewalk, walkway, and driveway. SES received the topsoil from EME. The source of the material was located in New Egypt, New Jersey. Approximately 122,363.68 tons of common fill and 2,751.52 tons of topsoil were utilized to fill the OU1 Phase 2 excavation areas.

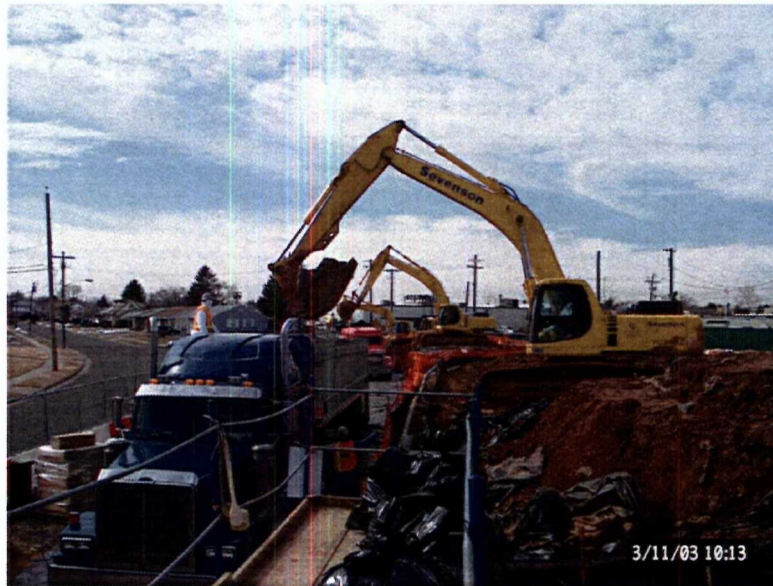
Photo 3-6 – Truck Loading Operations

Material to be disposed of at Subtitle C and D facilities were transported to their respective facilities by utilizing 70,000-lb triaxle dump trucks. Material requiring thermal treatment and disposal was loaded into 80,000-lb dump trailers for transportation to the thermal treatment facility. Trucks transporting excavated material to the facilities were required to be lined, tarped, and decontaminated (tire wash) prior to leaving the site.

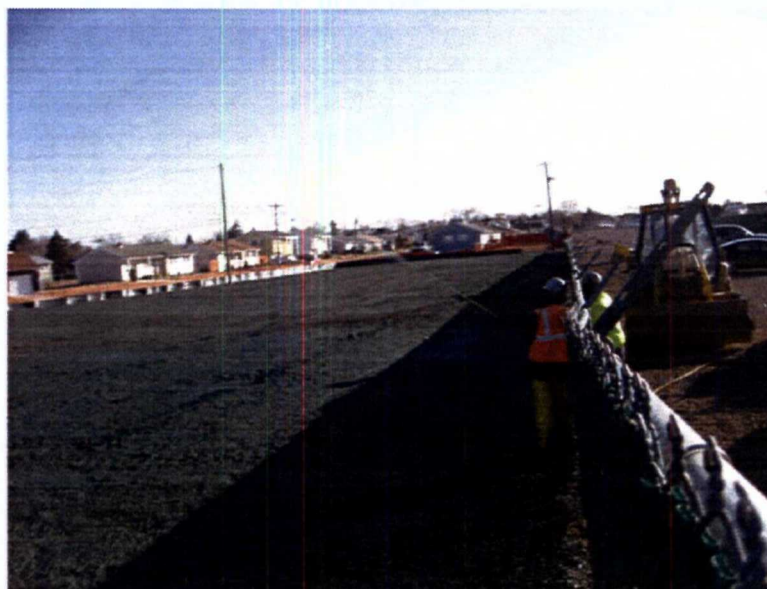
Photo 3-8 - Site Restoration

Property features impacted by construction activities were restored and/or replaced in kind by the contractor. The OU1 Phase 2 properties - 66 through 110 Valerie Drive - were restored as vacant lots ready for development. The properties were graded in a manner that is uniform, consistent with the existing topography, and re-vegetated with grass, according to the restoration plan in the design package. The property restoration at 116 Valerie Drive involved replacement in kind of items in the yard where construction took place. Sod was used to replace grass on this property. Roadways, curbs, gutter, asphalt pavement, and sidewalks impacted by the remedial activities were also restored and/or rebuilt as shown on the restoration plans included in the contract drawings. Grass areas were restored with sod. Excavated areas were graded to closely follow the pre-excitation grades. Landscape items such as trees and shrubs removed during remedial activities were replaced as shown on the contract drawings. A row of pine trees was planted in the Norfolk Southern Railroad right-of-way near the property line. Utility service laterals impacted by the excavation were also restored. Utility work was performed by the respective utility companies or their authorized representatives, except for water, sanitary, and storm sewer work, which was performed by SES.
